# Surface Water and Ocean Topography (SWOT) Mission

## Science Team Meeting

**KaRIn FPGA reconfig**

# Overview

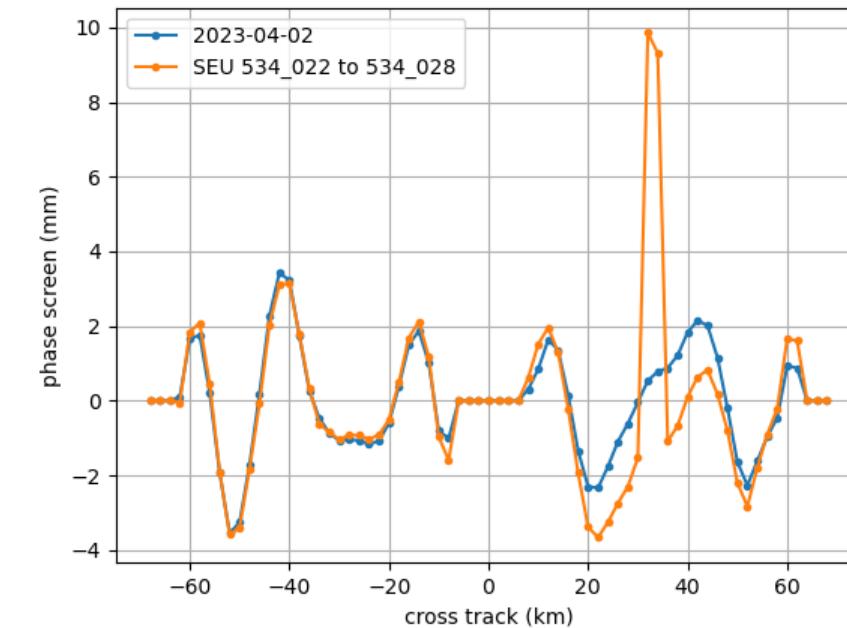
Phase screen computed from data affected by SEU differs from that of unaffected data.

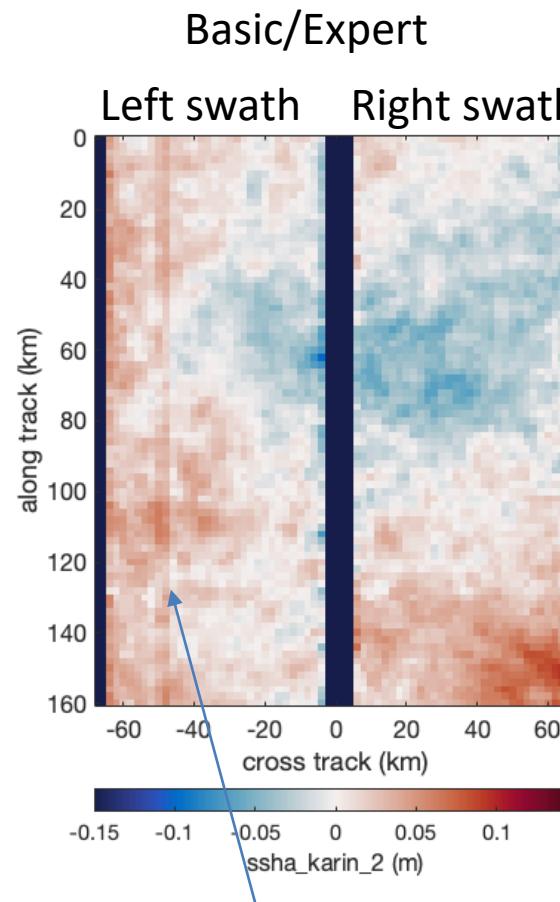
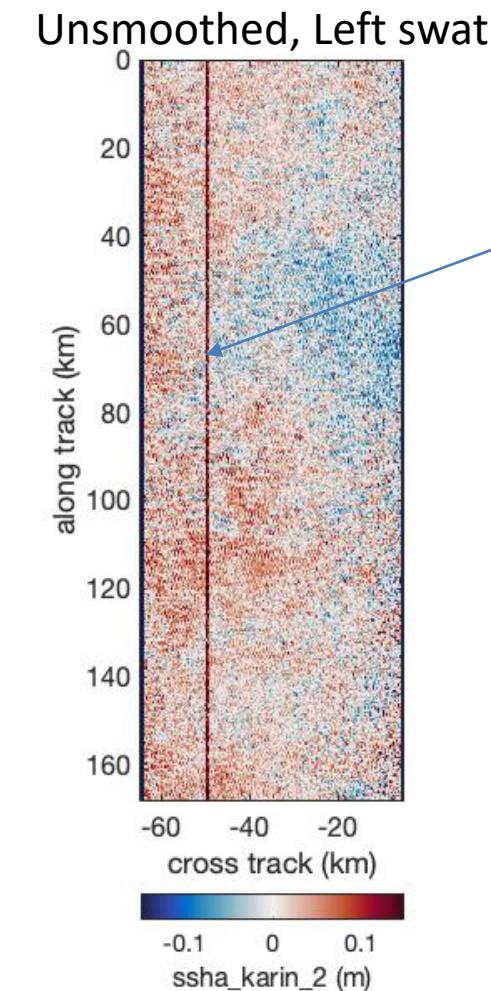
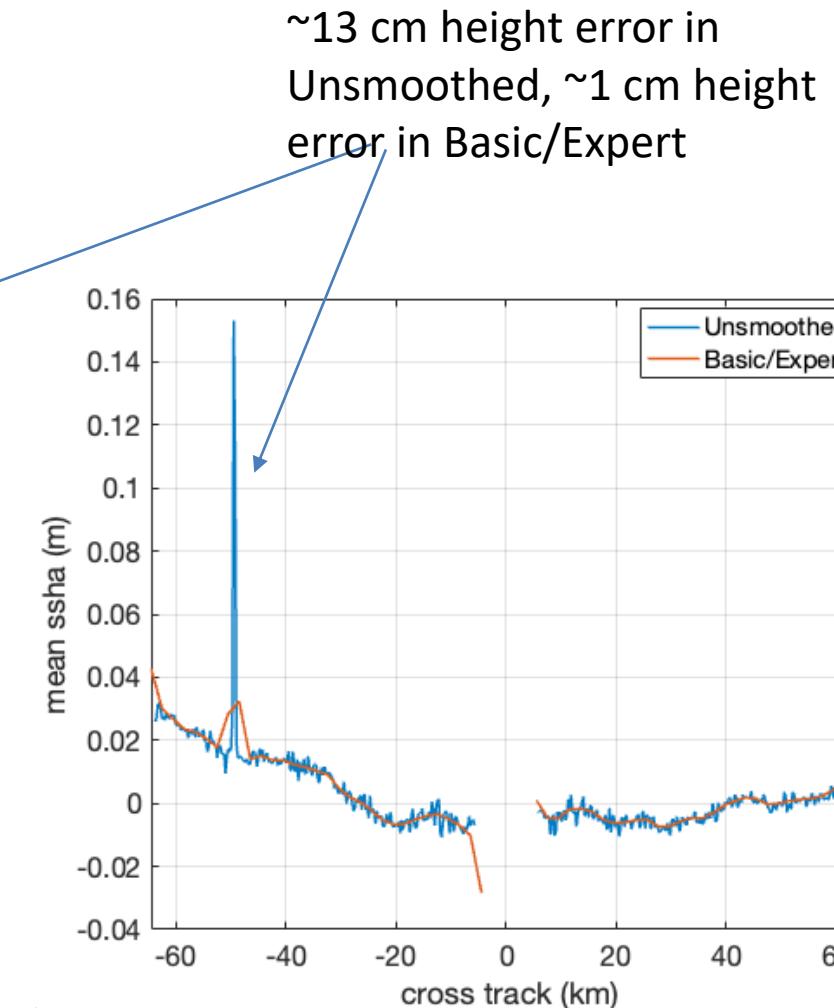
Example SEU artifact, which affected cycle 010, pass 033 to 039.

Plots show Pass 037 around 32.7°

~1 cm height error in  
Basic/Expert

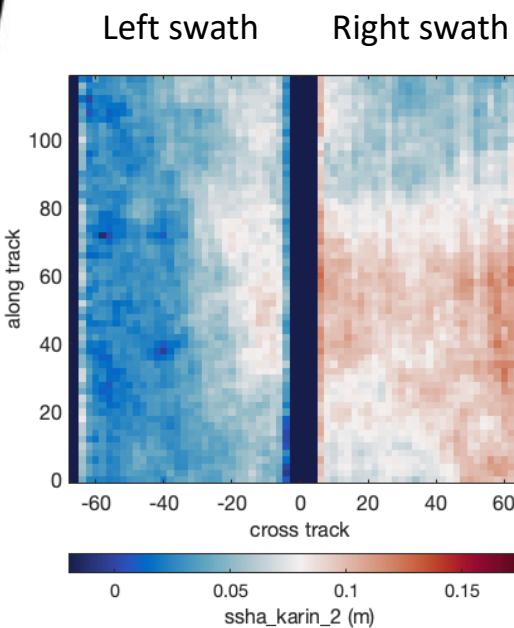
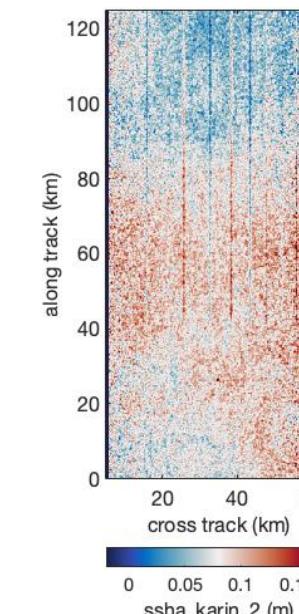
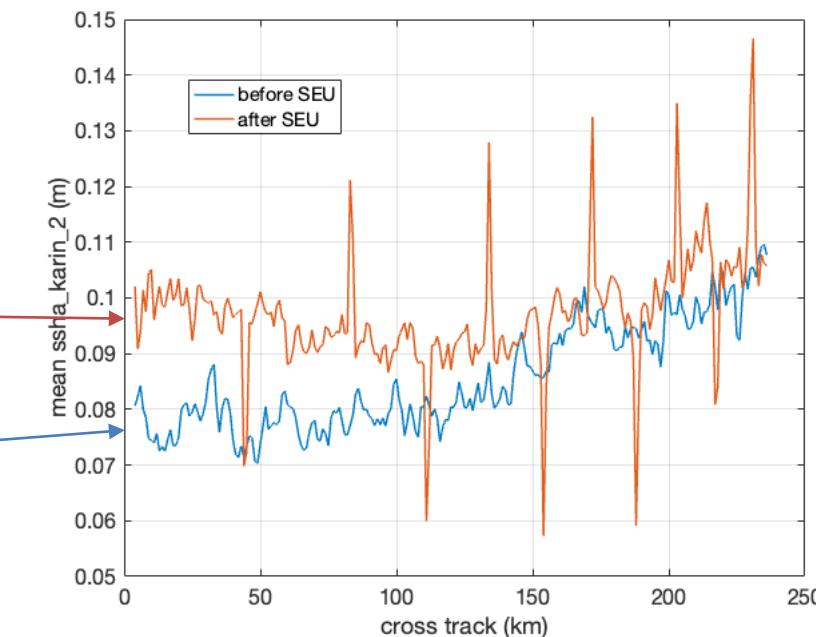
Example SEU artifact, which affected cycle 003, pass 365 to 368.

Plots show pass 365 around  $26.5^{\circ}$  S,  $36.3^{\circ}$  W (in South Atlantic Anomaly)

Along-track mean of unsmoothed ssha,  
Right swath

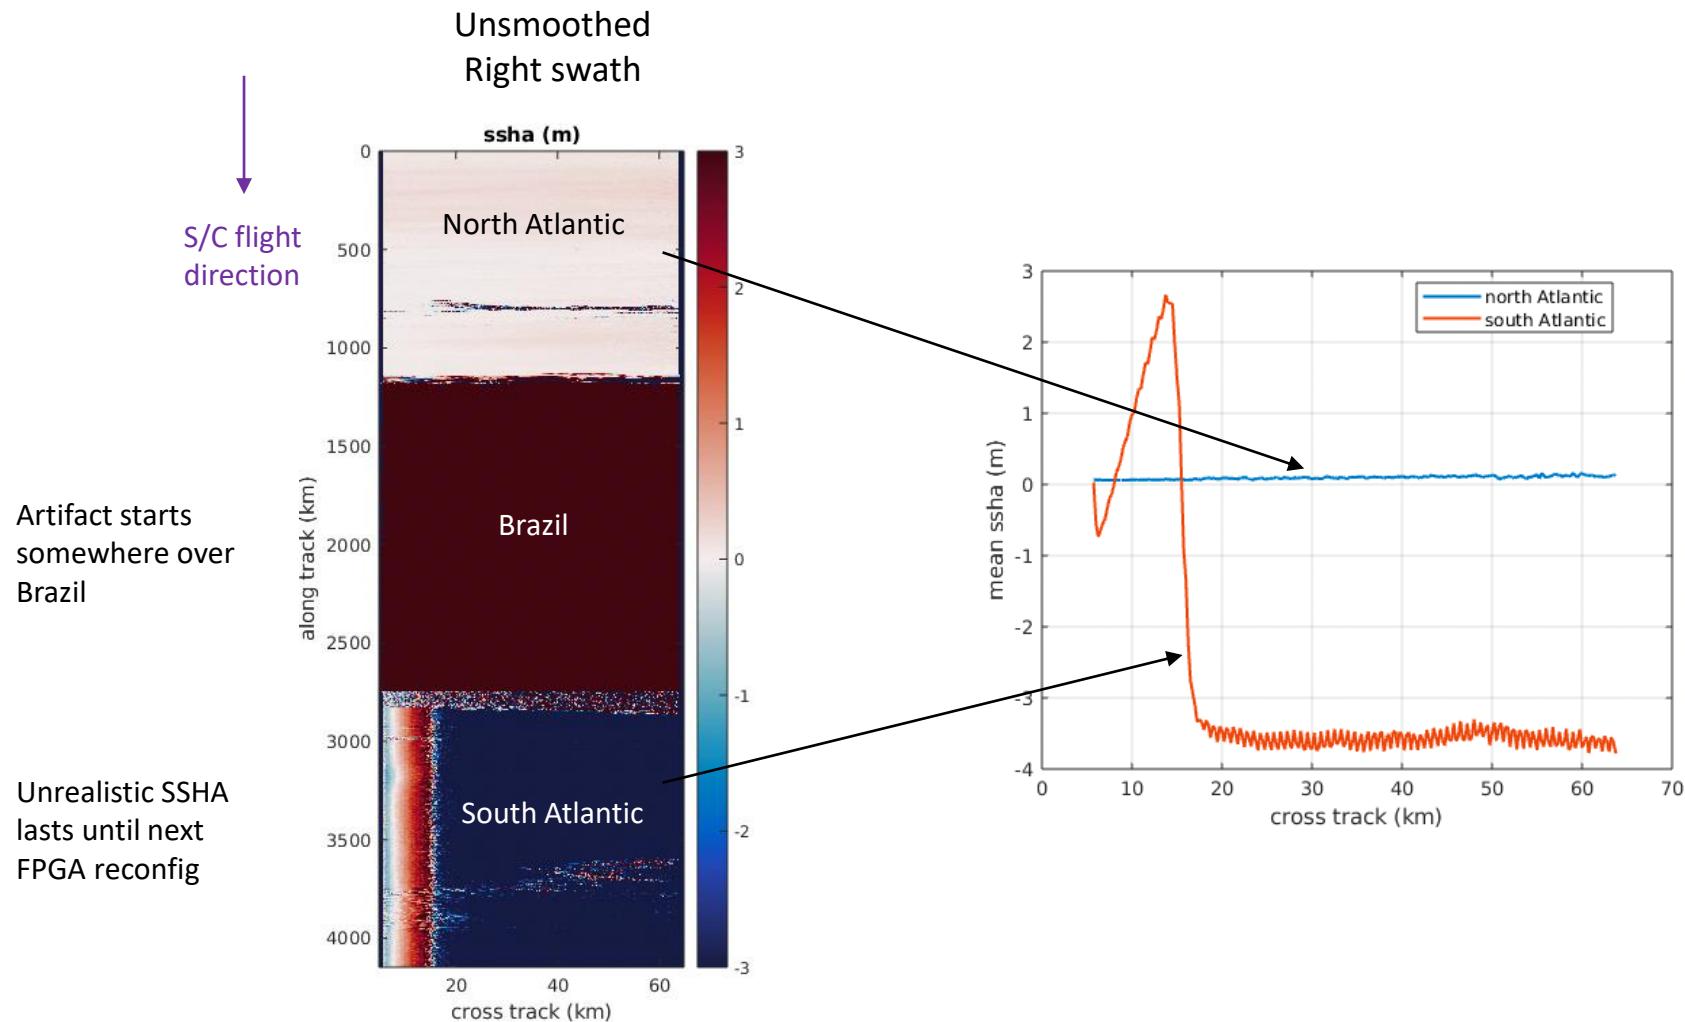
Example SEU artifact, which affected cycle 031, pass 352 to 354.

Plots show pass 352 between 10° N and 35° S.

Note: This example looks very different from the others. SEU effects are unpredictable and depend on which bit(s) in OBP got flipped.

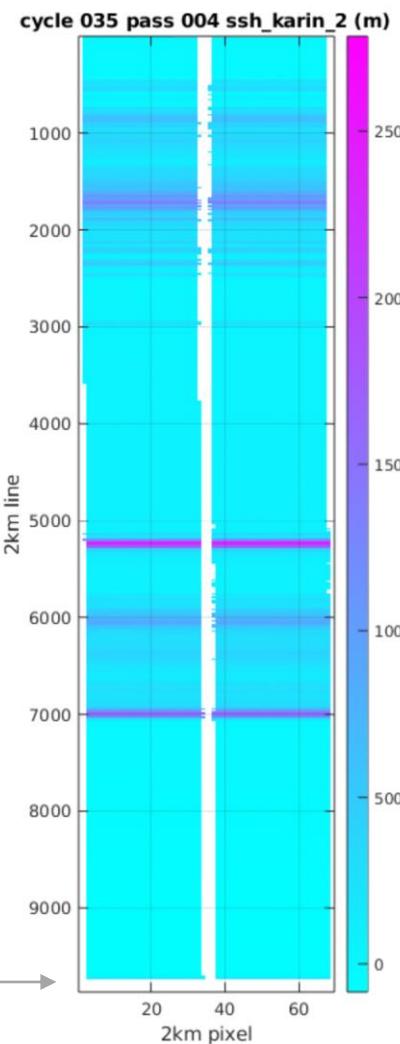
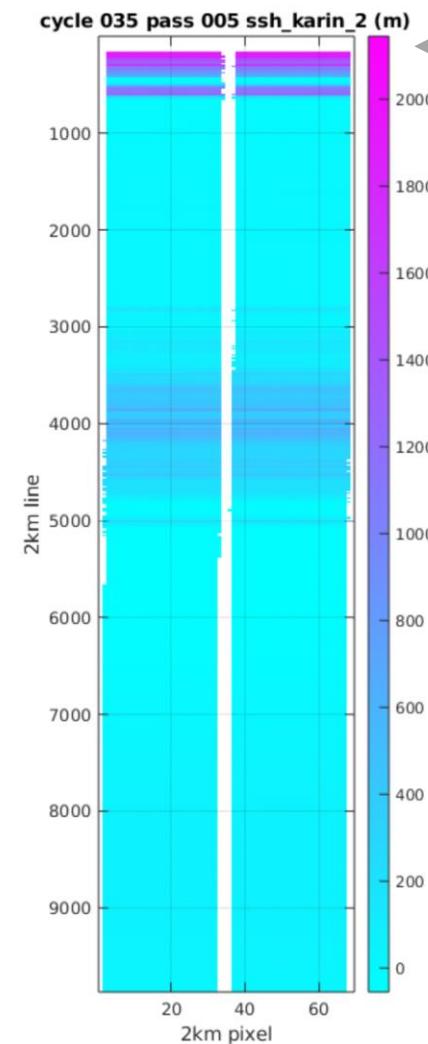
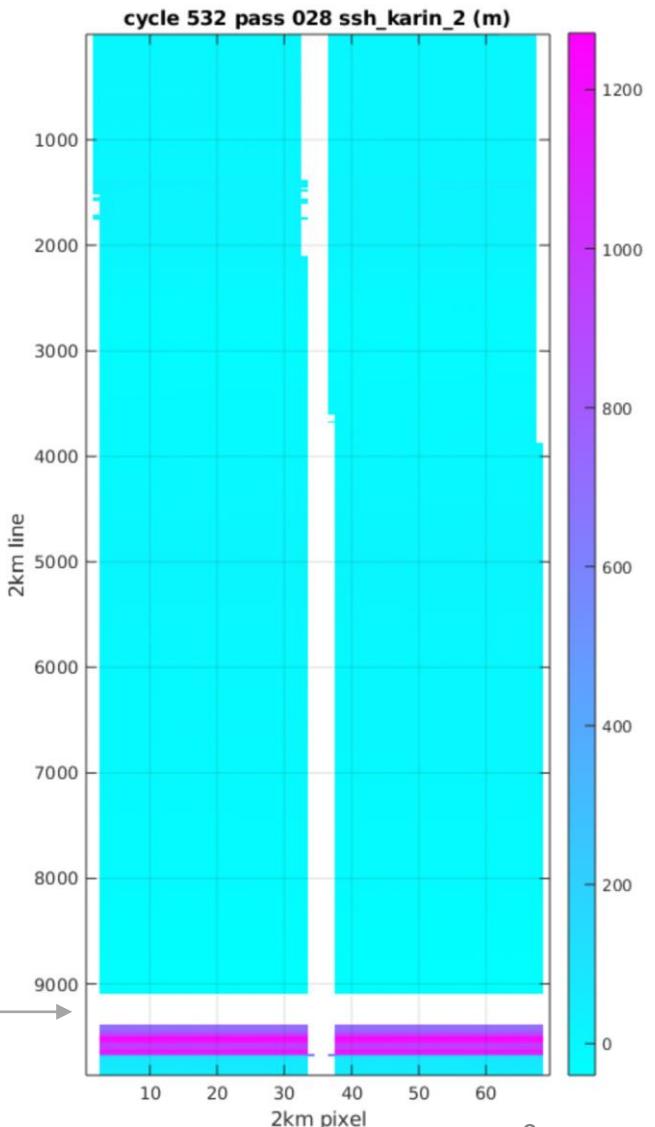
Cal/Val orbit pass 28 has reconfig here.

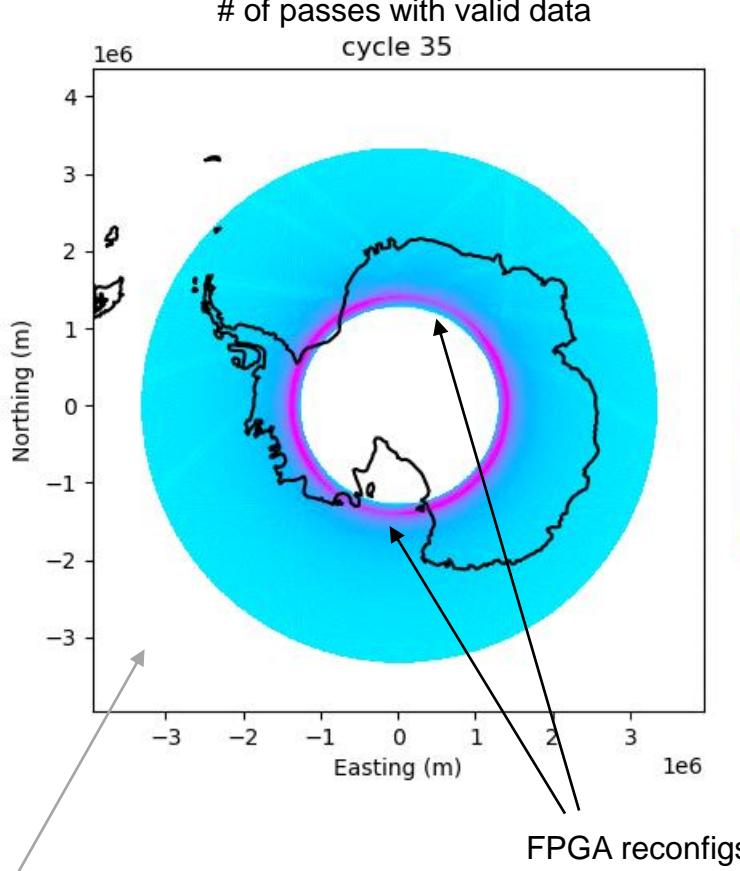
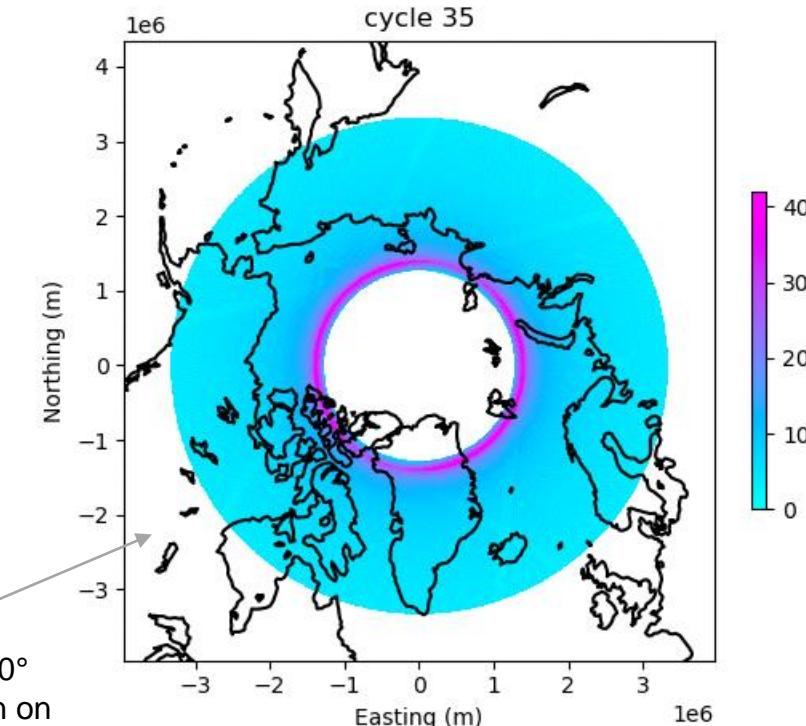
- The plots shows maps of how many KaRIn passes have valid data over each point in the polar regions for cycle 35.
- There is less coverage in the areas where FPGA reconfigs happen, but we still have at least one pass everywhere.
